THE BEHAVIOUR OF THE INSTRUMENTATION OF AN EMBANKMENT ON CLAY

J. A. Ramalho-Ortigão¹, Willy A. Lacerda²
and Mauro L. G. Werneck²

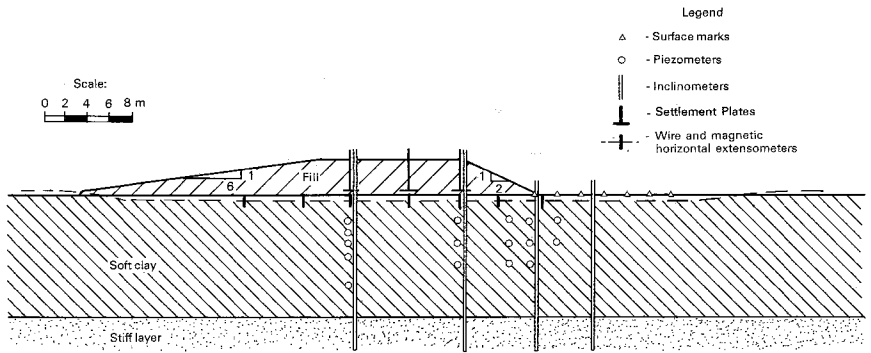
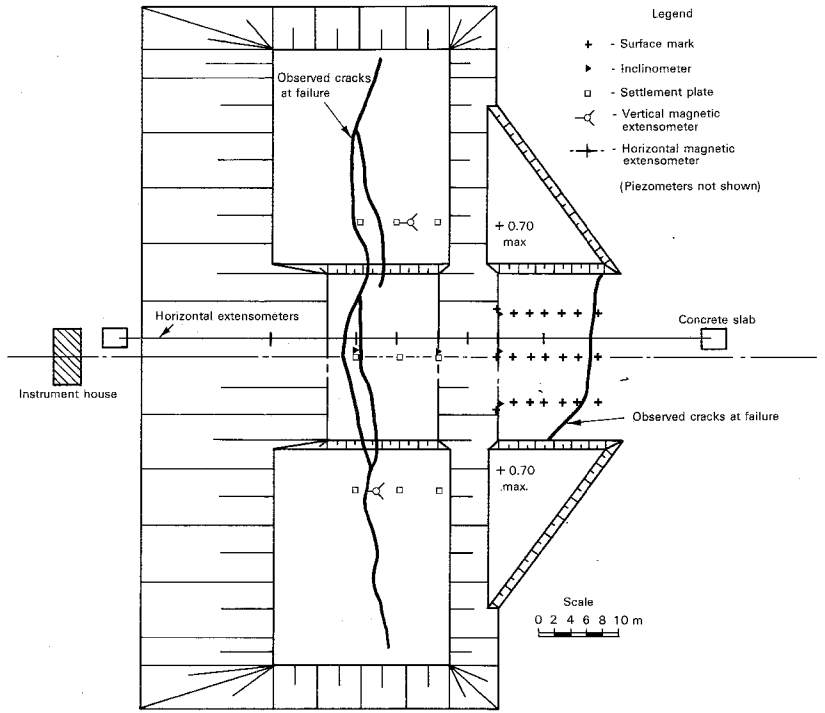
Fig. 2 Layout of the instrumentation

The first cracks were observed when the embankment height was 2.5 m. At a height of 2.8 m severe cracking on the embankment crest occurred and marked changes were observed in the readings of some instruments. The embankment height was then lifted to 3.1 m, the number of cracks increased considerably and failure propagated (see figure 2).

Settlement monitoring at lateral or secondary instrumented sections were made through settlement plates and vertical magnetic extensometers, aiming at observing post-failure settlements. However, when the embankment failed, severe cracking also spread along the lateral sections (see figure 2), causing a sudden variation of the measurements. Thus, lateral settlement measurements have only been used for evaluating instruments performance. The experience so obtained, allow the writers to quote the accuracy of vertical magnetic extensometer in the order of ± 2 mm.

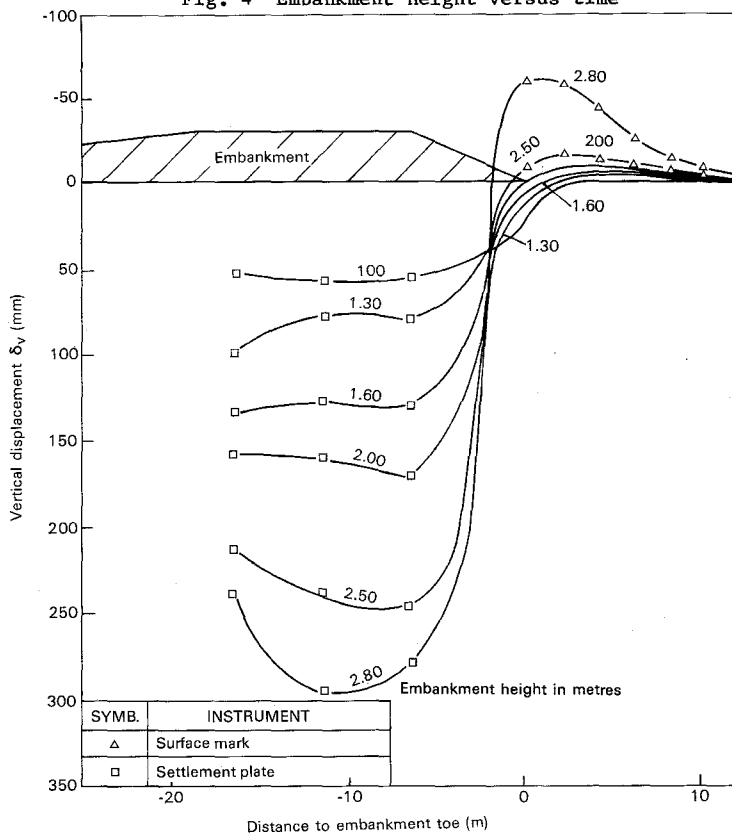
Fig. 5 Vertical displacement profiles under the base of the embankmen

Vertical displacement profiles under the base of the embankment are shown on figure 5. At failure, the maximum observed settlements were in the

order of 300 mm, while ground heave near the toe of the embankment was about 50 mm. When the embankment height was increased from 2.5 to 2.8 m, a sudden change in heave observations was recorded. These readings show a 2 to 3 - fold sudden variation near failure. Another noticeable point on figure 8, is the high gradient of vertical displacements which occurs near the toe of the steeper slope of the embankment. At this position vertical movements at clay surface present a significant variation from positive (settlement) to negative (heave) in a few meters of horizontal distance.

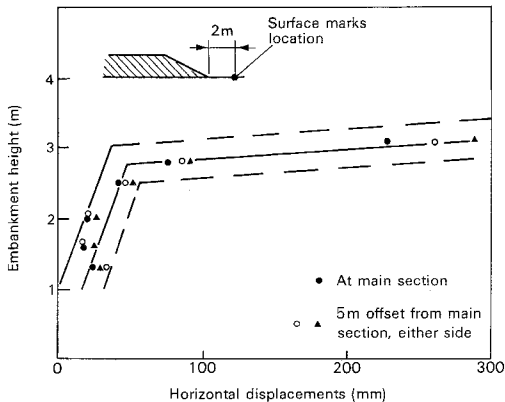
Fig. 6 Measurements on surface marks

Observations of horizontal displacements by the surface marks versus embankment height are shown in figure 6. These measurements, taken at a distance of 2 m of the embankment toe, were preferred to those taken at the toe, which may have been affected by shocks during fill placement. The figure shows a sudden increase in the displacement measurements near failure preventing their use as an indication of imminent instability.

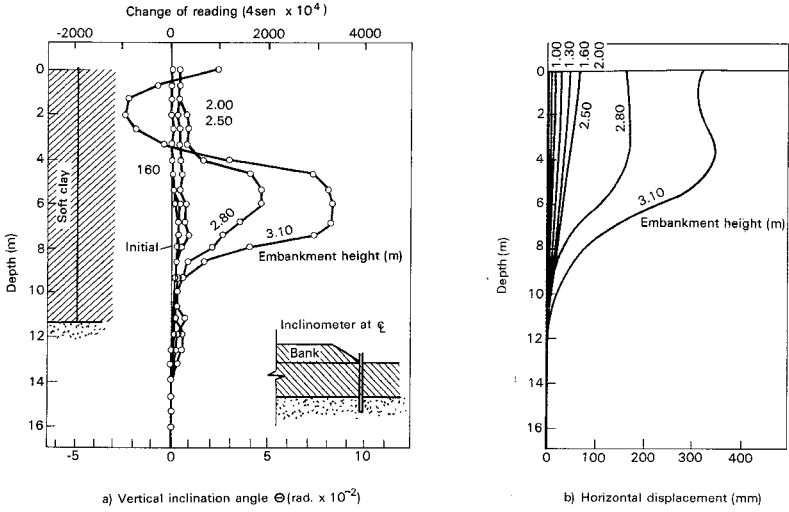
Fig. 7 Incliner observations

Inclinometer observations in one casing positioned at the toe are shown in figures 7 and 8. Figure 7(a) presents the variation of angle θ , ie the observed vertical inclination with depth. The horizontal displacements are shown on figure 7(b). Figure 8 shows the backfiguring of the slip surface (assumed to be circular) employing inclinometer observations.

Field observations during the construction have allowed an evaluation of available methods of stability control for application to Rio de Janeiro clay (Ramalho Ortigão et alii, 1983). The experience gained has demonstrated that, among all instrument observations, the inclinometer readings were the most affected by the imminent failure. As can be seen from figure 7, a sudden change on the readings was observed just before the embankment had failed. Maximum values of vertical inclination, rather

than horizontal displacements, were employed, since these measurements can be directly related to shear strains. In fact, the shear strain γ_{vh} is a sum of the vertical inclination θ plus the horizontal inclination β at the same point. The θ values under the embankment toe were directly measured by the inclinometer and β values were not measured. However, at a point located near the horizontal part of a failure surface (see Gould and Dunnicliff, 1971) β may be very small. Thus, the shear strain γ_{vh} could be considered to be equal to θ_{max} , ie the maximum observed vertical inclination measured at the embankment toe. The observed behaviour has demonstrated that severe embankment cracking took place when shear deformations indicated by the inclinometer were greater than 3%. This value has been, then, suggested as a limit for construction control for stability on Rio de Janeiro clay.

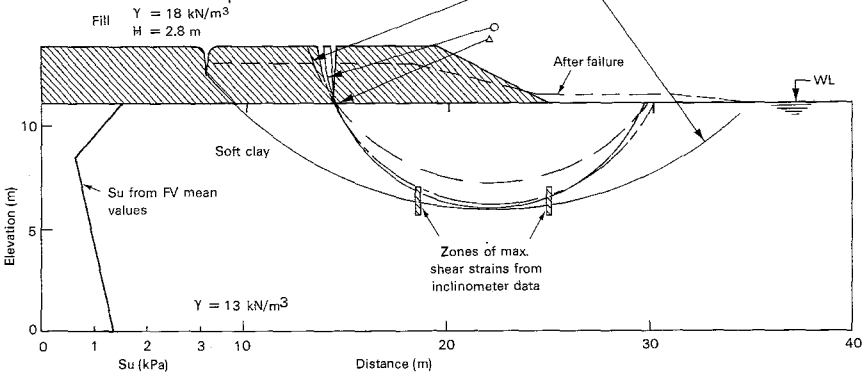
Fig. 15 Results of the total stress stability analysis

Stability analyses of the trial embankment have been described elsewhere (Ramalho Ortigão et alii, 1983). A summary of the results in terms of total stresses are shown on figure 15. A Factor of Safety very close to one was obtained for failure conditions when mean values of field vane tests were employed. The mean field vane results which yielded $FS \approx 1$ were crude or uncorrected results, which suggests that Bjerrum's correction may not be applicable to Rio de Janeiro grey clay.
