# EMBANKMENT FAILURE ON CLAY NEAR RIO DE JANEIRO

By J. A. Ramalho-Ortigão,<sup>1</sup> M. ASCE, Mauro L. G. Werneck,<sup>2</sup>  
and Willy A. Lacerda<sup>2</sup>

**ABSTRACT:** The construction on an instrumented trial embankment on soft clay is described. Field measurements of pore-pressure and vertical and horizontal displacements were carried out and the results are discussed. Foundation strength was evaluated through vane tests, UU triaxial tests and SHANSEP method. Embankment failure occurred when its height was about 3 m. Stability analysis were carried out to evaluate methods of assessing soft foundation strength.

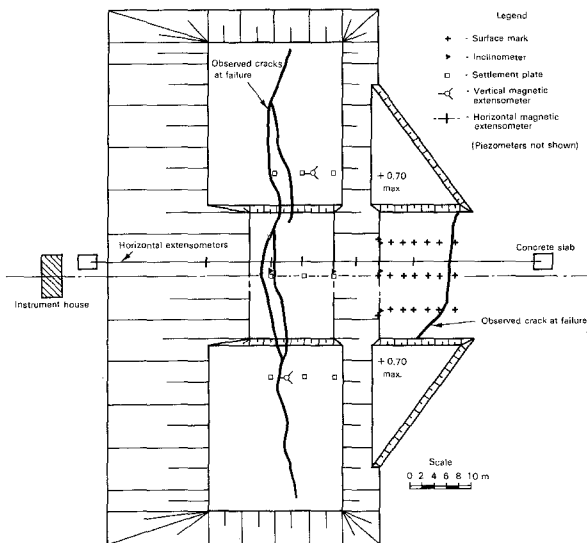
FIG. 6.—Instrumentation Plan

On the following morning it was decided to accelerate embankment deformation rate by placing another layer. As soon as placement was resumed, a general slip slowly occurred and the embankment height could not be increased. This occurred on December 7th, 1977, *exactly a month after the beginning of the fill placement*. Final geometry was then surveyed and final cracks are shown on Fig. 6.

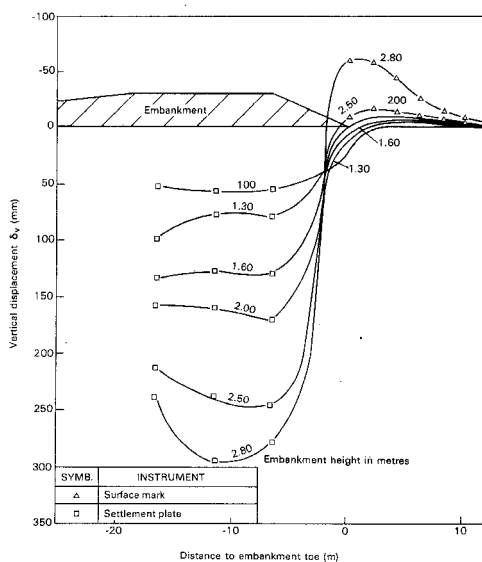
FIG. 8.—Vertical Displacement Profiles under Base of Embankment

Vertical displacement profiles under the base of the embankment are shown in Fig. 8. At failure, the maximum observed settlements were in the order of 300 mm, while ground heave near the toe of the embankment was about 50 mm. When the embankment height was increased from 2.5–2.8, a sudden increase in heave observations was recorded. These readings show a 2–3-fold sudden variation near failure. Another noticeable point in Fig. 8 is the high gradient of vertical displacements which occurred under the toe of the steeper slope of the embankment.

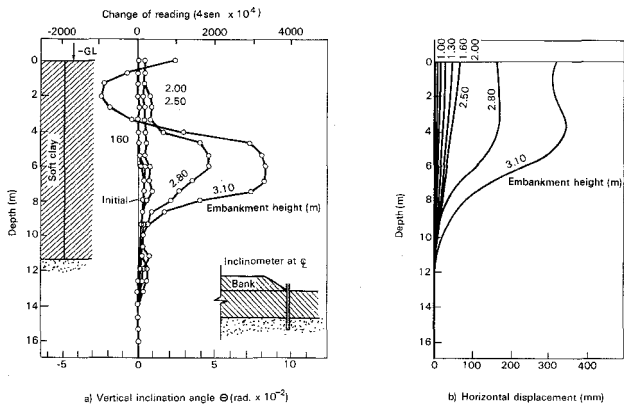
FIG. 9.—Inclinometer Observations

Inclinometer observations at one casing positioned at the toe are shown in Fig. 9. Fig. 9(a) presents the variation of angle  $\theta$ , i.e., the observed vertical inclination with depth. The horizontal displacements are shown in Fig. 9(b). Observations have shown that transverse horizontal displacements were negligible. The ratio of longitudinal (along the embankment center line) to transverse displacements was negligible: less than 5% in the main section and less than 10% in the two inclinometers off the main section.

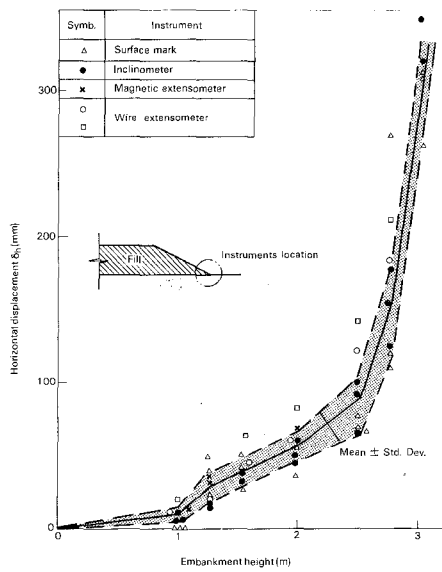
FIG. 10.—Observed Horizontal Displacements at Embankment Toe

Horizontal displacements at the toe are summarized in Fig. 10, and Fig. 11 presents typical results of horizontal displacement measurements along the embankment base. At the end of fill placement maximum toe horizontal displacements are in the range of 300–400 mm. Maximum values, as seen in Fig. 11, seem to occur under the steeper embankment slope, rather than at the toe. The zone of influence of ground displacements does not extend beyond 10 m from the embankment toe.

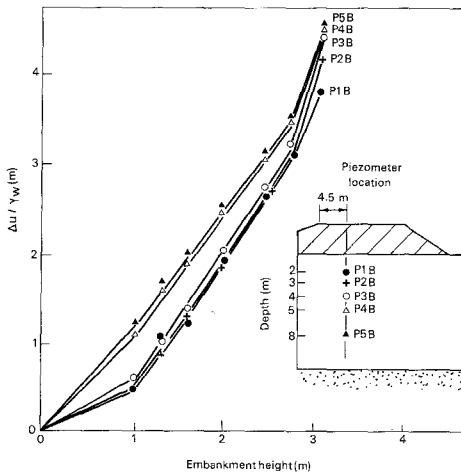
FIG. 12.—Construction Pore Pressures

load, as shown in Fig. 12, presents an initial flatter slope for the porous tips located closer to the top of the clay layer, followed by a steeper slope. This typical behavior has been analyzed by Lerouiel, et al. (13), who attributed the change in the rate of pore-pressure buildup to the fact of the clay foundation passing from overconsolidation into a normally consolidated state. At failure, as local yield occurs close to the porous tip, pore pressures seem to present a further increase in the rate of pore-pressure generation.

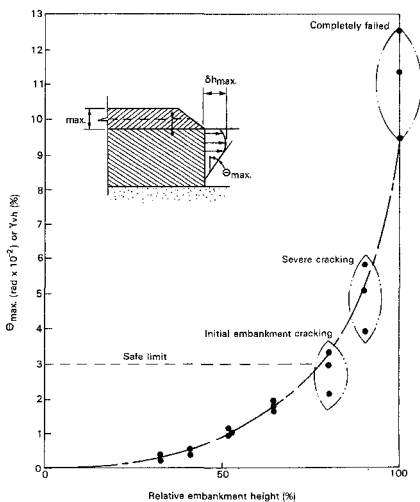
**FIG. 14.—Stability Control Chart through Inclinometer Observations at Embankment Toe**

Data in Fig. 14 was obtained from three inclinometer casings. Correlating these observations with the observed embankment behavior, a safe limit of  $\gamma_{vh}$  or  $\theta_{max}$  equal to 3% could be defined. Beyond this safe value, severe embankment cracking was observed in the trial embankment.

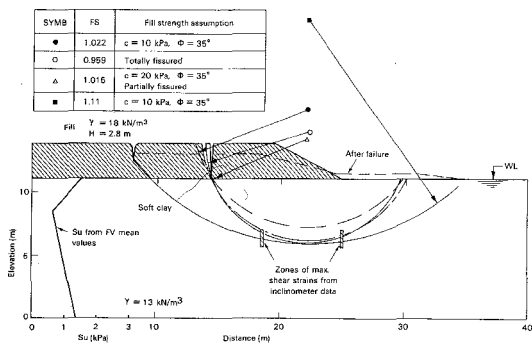
**FIG. 17.—Results of Total Stress Stability Analysis**

Fig. 17 summarizes, the final results of total stress stability analyses. A FS very close to one was obtained. It can be seen that calculated and "observed" failure surfaces are in good agreement with regard to the maximum depth reached by these surfaces. The figure also shows that the calculated minimum value of FS is about 10% lower than the FS of the "observed" failure surface. The relatively small contribution of the embankment strength on the calculated FS is also shown in Fig. 17.

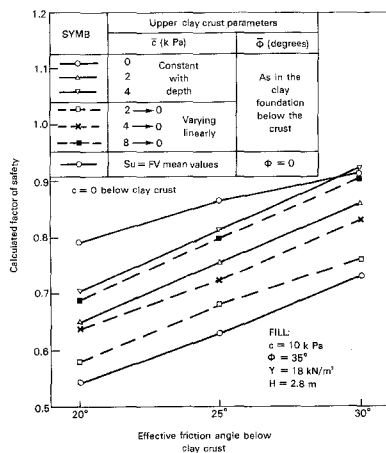
FIG. 18.—Results of Effective Stress Stability Analysis

25° were selected for the analysis. The embankment height at failure was set at 2.8 m and fill strength parameters were chosen from the previous total stress analysis as  $c = 10$  kPa and  $\Phi = 35^\circ$ . These input data yielded a very low factor of safety of about 0.6. Additional analyses were then carried out varying soil parameters to account for possible errors in  $c$  and  $\Phi$ , mainly at the upper clay crust. The results are summarized in Fig. 18 which shows that the calculated values of factor of safety are well below one.
