Embankment Failures on Soft Clay in Brazil

J.A. Ortigao

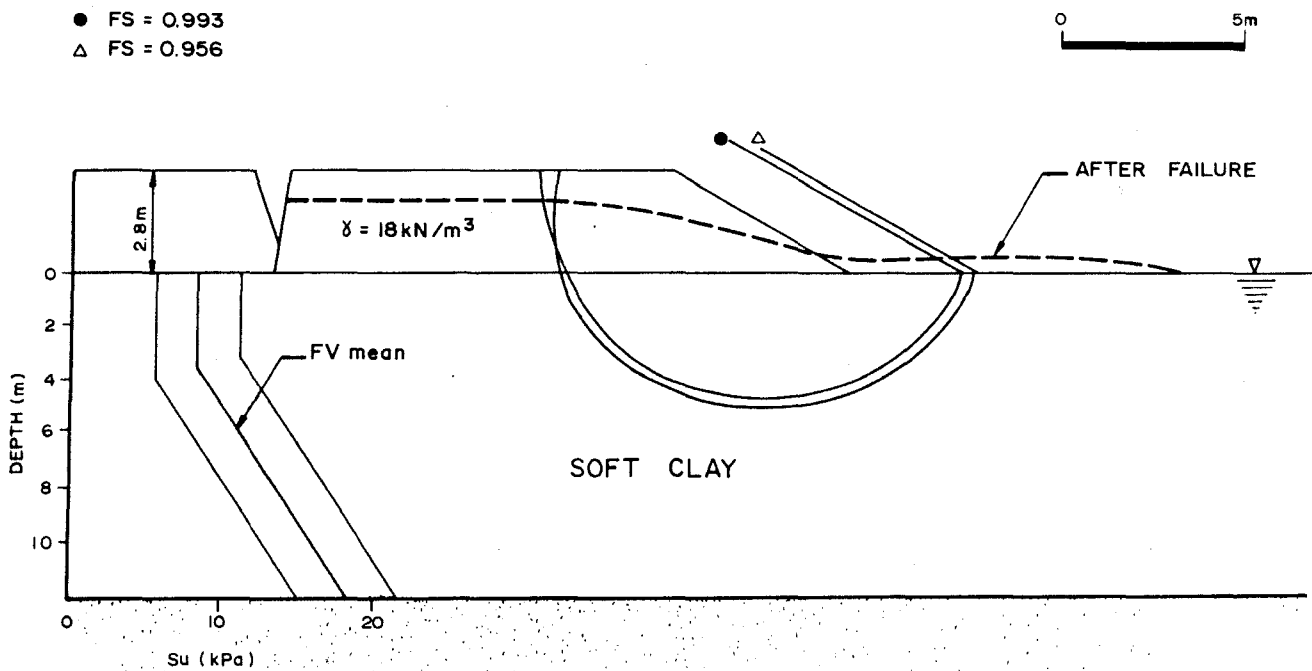
Figure 2 - Case 1 - Failure on Rio de Janeiro clay [6]

Case 1 - A full scale instrumented trial embankment was carried out at site 1 on Rio de Janeiro clay, in 1977 [6]. The ground consists of soft marine clay with liquid limit (*LL*) from 120% to 160%. The water content (*w*) ranges from 120 to 180%, the plastic limit (*PL*) from 60 to 80% and mean plasticity index (*PI*) of around 80%. The field vane (*FV*) shear strength *s_u* of the clay varies from 8 to 18 kPa, as shown in the profile in figure 2, the mean value being 10 kPa [5]. Table 1 summarizes these soil properties.

Figure 2 shows the geometry of the embankment just prior to failure. A stability analysis using uncorrected *FV* strength profile using Bishop's simplified method gave a factor of safety (*FS*) close to one, which closely matches the observed behaviour. Still, Bjerrum's [2] field vane correction factor for a clay showing *IP*=80% is 1/1.6, which would result in a reduction of the strength to be used in analyses.

At the time of the trial, it was argued that the *FV* correction was not necessary. The reasons were: the high plasticity of the clay, marine origin, mineralogy and organic content of the clay. Additional experience was necessary to confirm this. Since then, additional case histories have been added to the Brazilian data base.

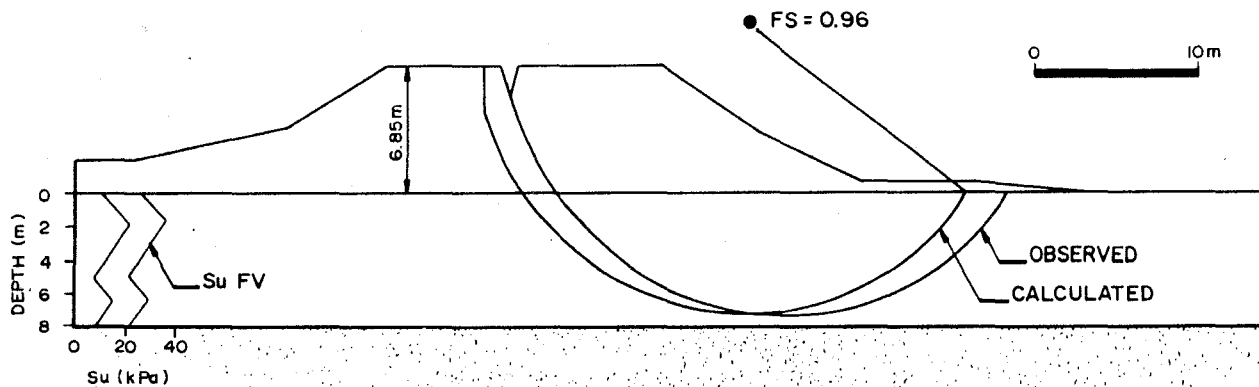
Figure 3 - Case 2 - Juturnaiba trial embankment [3]

Case 2 - Another full scale instrumented embankment failure was carried out at site 2, about 150 km north of Rio de Janeiro, at the site of Juturnaiba Dam [3]. The soft ground has 7m of interlayered soft alluvial organic clay and peat, with *PI* between 40 to 80% for the clay layers. Mean *FV* strength value was 20 kPa, but data showed considerable scatter and its was difficult to select a design

Figure 3 shows the embankment cross section. The embankment failed when its height reached 6.85m. A total stress stability analysis employing the uncorrected mean strength profile and considering cracking in the embankment material (ie, reduced embankment strength) yielded a factor of safety of 0.96, closely matching the observed behaviour (table 1).
