# Remote instrumentation of Itanhanga Hill

*2<sup>nd</sup> PSL Pan Am Symposium on Landslides*

Rio de Janeiro  
1997

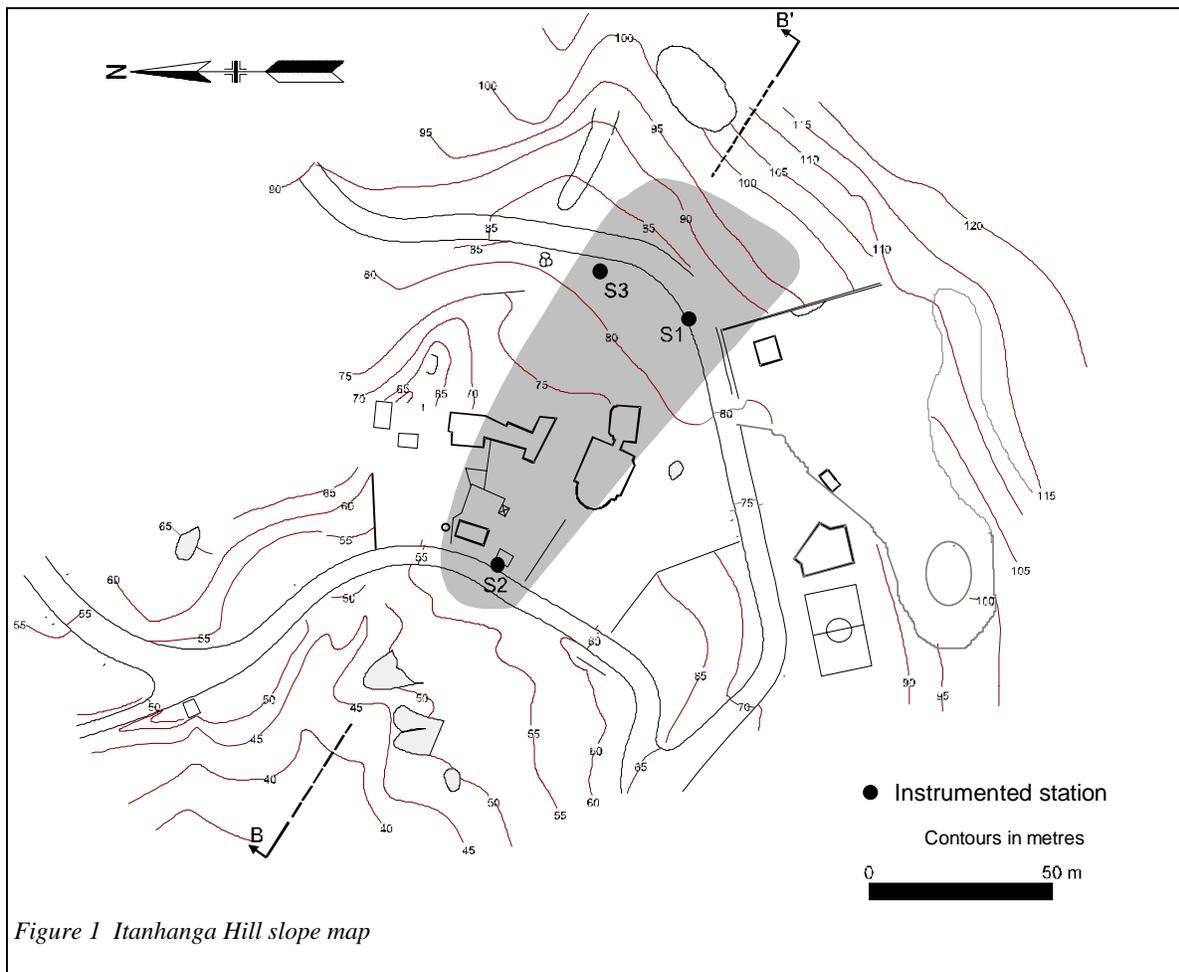
The works on the Itanhanga Hill were resumed in May 1996. Detailed surveying and mapping in the 1:500 scale and geological interpretation was carried out and a summary of the results is presented in Figure 1. The shadowed area in this figure corresponds to the zone affected by slope movements, as a results of plotting the damages to constructions, walls, tilting of trees and poles and pavements. The results of the site investigation and the boreholes are summarised in the cross section presented in Figure 2.

The damages caused by mass movements consisted of misalignment of kerbs, electricity poles and trees and wall and floor cracks, which were detailed recorded in resulting map. They seem to be aligned, as indicated in Figure 1, indicating a tongue of mass movements.

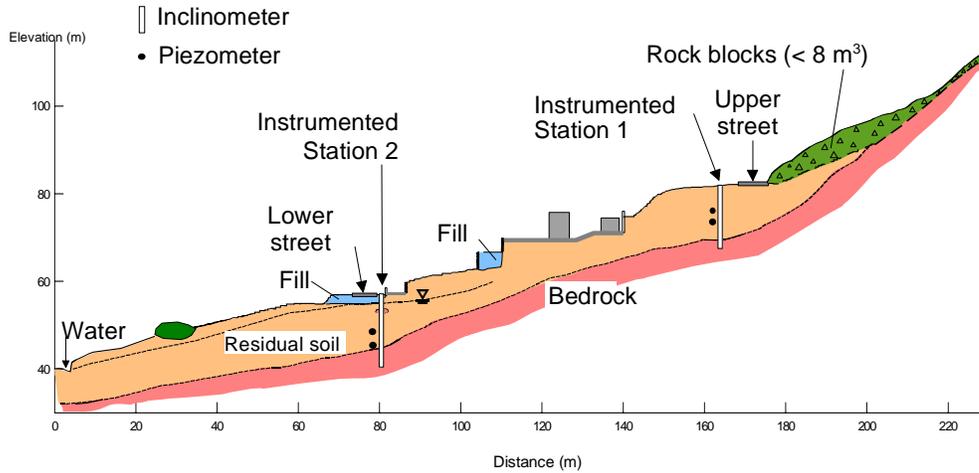
Figure 2 Cross section BB'

The region has a characteristic geology of the Serra do Mar gneisses. The rock steep scarp is intercepted by soils at the elevation 110 m (Figure 2) which present a low inclination averaging 15 degrees. The main lithology consists of biotite quartz microcline augen gneiss. The foliation is wrapped around the relative large eye-shaped feldspars in stream-line fashion and aligned in the NW-SE direction, dipping at 20 to 35 degrees NE. The exposed rock is sound to poorly weathered and presents few sub-vertical joints.

The soil profile in Figure 2 shows a gentle slope with a inclination averaging 15 degrees, with several man-made plateaux and light constructions of one to two-story houses. Descending from the rock scarp, the rock has

Initial investigation led to preliminary conclusion that the movements occurred in the colluvium. Further investigations have shown that the residual soil is up to 10 m deep and very little or no colluvium. Therefore the movements might have occurred in the residual soil layer.

The fill or colluvium layer is thin and in the order of 1 m deep only. The residual soils are up to 10 m thick and very dense, reaching SPT  $N$  values of over 30, overlying fractured rock. The boreholes indicated the presence of corestones surrounded by soil.

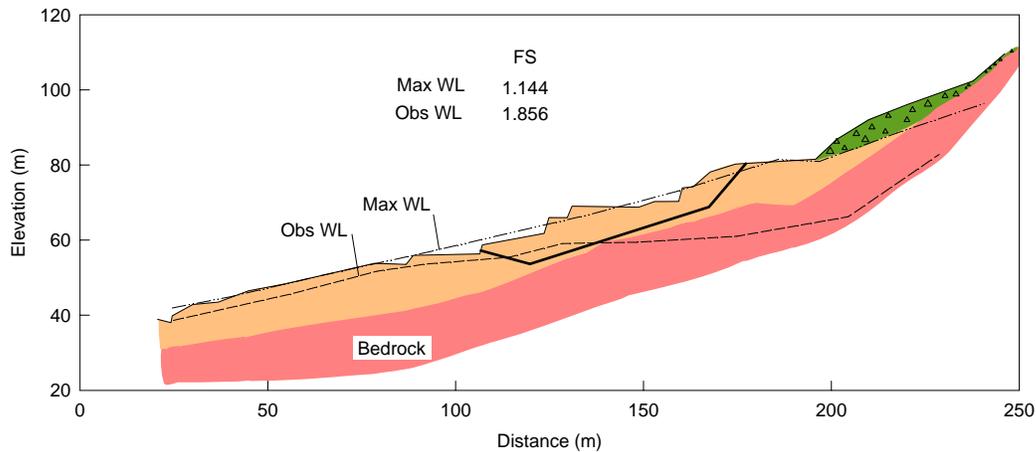
Figure 3 Results from the stability analyses

A summary of the results and the calculated factor of safety (FS) is given in Table 1. The critical slip surface for estimated maximum pore pressures at the rainy season is shown in Figure 3. The resulting FS was low as 1.144, which may explain the cause of the problem.

The geotechnical studies carried out at the Itanhanga Hill slope indicated that the estimated rise of porewater pressures during severe rainstorms can decrease the safety factor to a value close to one and trigger mass movements.

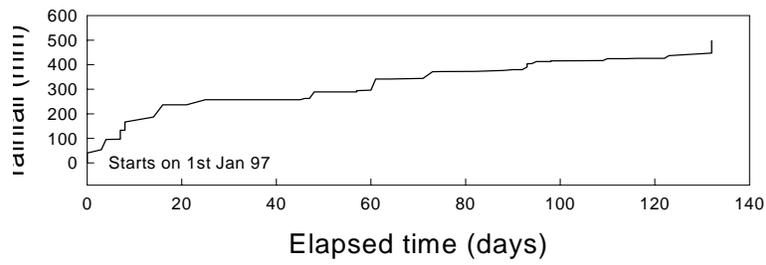
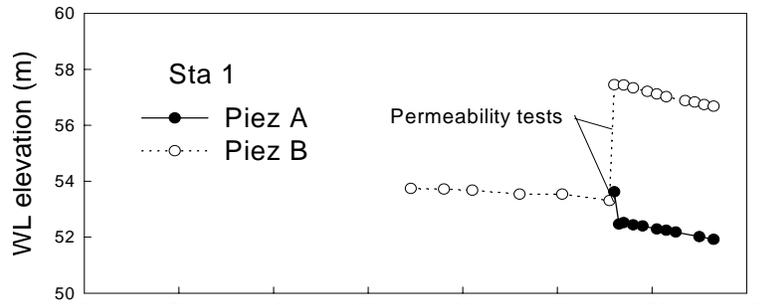
Figure 7 (a) Rainfall, water level and (b) permeability tests

Only a limited amount of data were obtained since the data acquisition system was installed in February 1997. No main rain-induced event or displacements were recorded up to the current time (May 1997). Figure 7a presents accumulated precipitation from 1<sup>st</sup> of January until 15<sup>th</sup> of May and Figure 7b shows water level records in two piezometers of Station 1 (Lower Street) from the start of measurements. A few days after data recording started, the water level in the piezometer access tubes was raised by filling it up with water, as showed in this figure, in order to evaluate the soil permeability around the porous tip, also as a test to instrument itself. After dissipation of the test excess porepressure, the reading in piezometer A seem to be decreasing due to lack of rainfall in the last month. Piezometer B did not dissipate rapidly, but at the same rate as in instrument A.

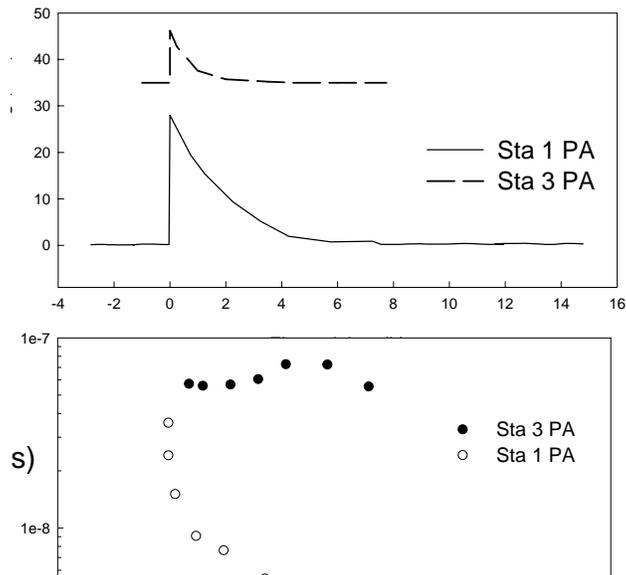
Figure 8 In situ permeability tests through the piezometers

The results of a few permeability tests were plotted in Figure 8a. Permeability values are indicated in Figure 8b, they were calculated through standard procedures given elsewhere (*e.g.*, Ortigao, 1995).
