Behaviour of Geogrid Reinforced Abutments on Soft Soil in the BR 101-SC Highway, Brazil¹

André R. S. Fabel¹, Ennio M. Palmeira¹ and J. A. R. Ortigão²

¹University of Brasilia, Department of Civil and Environmental Engineering, FT, 70910-900 Brasilia, DF, Brazil. ²Federal University of Rio de Janeiro, RJ, Brazil.

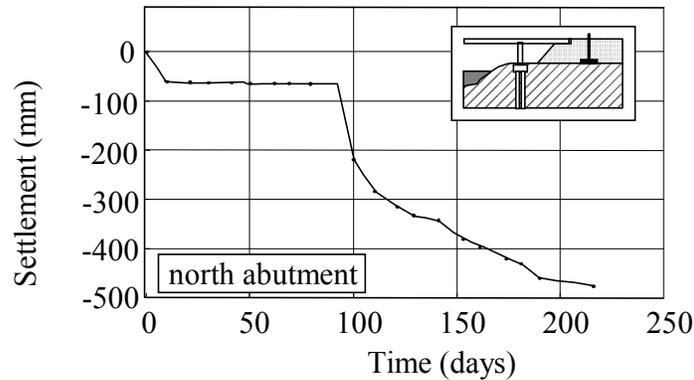
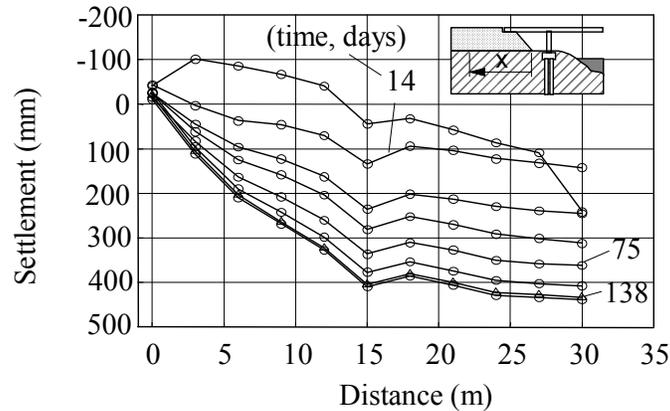
Figure 7. Settlement Data of the Abutments

Figures 7(a) and (b) show the variation of settlements with time for the abutments. Figure 7(a) shows the settlements measured by the settlement plate SP2 (Fig. 5) and Figure 7(b) shows the settlement profile along the embankment axis for the South abutment, as measured at different times by the multi-point settlement gauge. Settlement values as high as 0.5m can be observed in both cases.

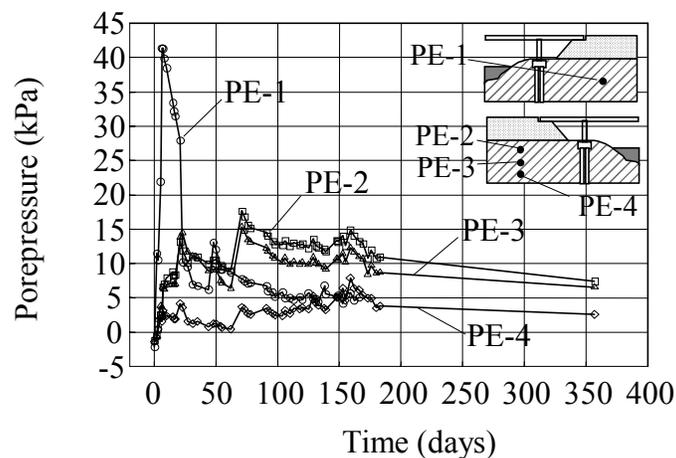
Figure 8. Porepressure Generation Versus Time

Porepressure generation with time is presented in Figure 8. A steep increase of porepressure with time for piezometer PE-1 can be noticed within the first 30 days

of construction, in contrast to the behaviour of the other piezometers. This is explained by the fact that the piezometer PE-1 is located in the North abutment which was raised very quickly, and suffering stability problems as mentioned previously. When signs of instability appeared the surcharge was removed and a berm was constructed, reducing load on the soft soil and allowing the dissipation of the porepressure in piezometer PE-1. Porepressure values up to 41 kPa were observed in piezometer PE-1. Piezometers PE-2 to PE-4, below the South abutment, presented a different pattern of pore pressure generation because of the construction procedure employed in this case. In these piezometers the porepressure values reached up to 18 kPa.

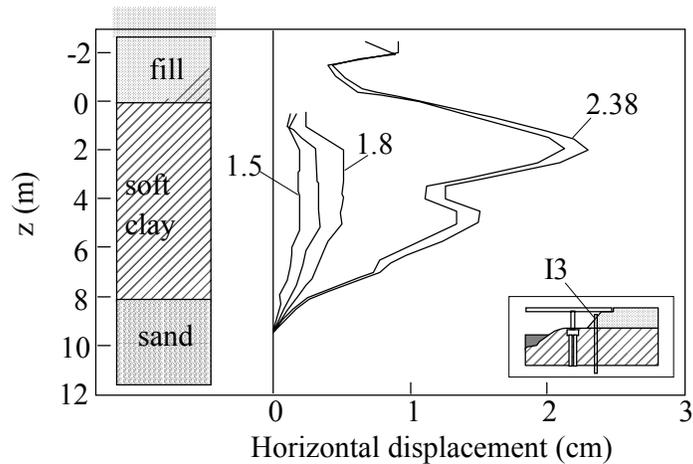
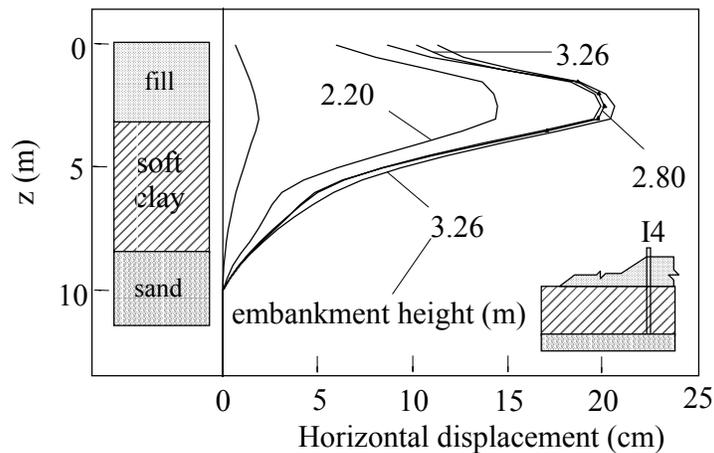
Figure 9. Horizontal Displacements in the North Abutment

Figures 9(a) and (b) show the horizontal displacements measured by inclinometers I3 and I4, in the North abutment (Fig. 5), respectively. Inclinometer I3 was installed at mid length of the embankment slope of the North abutment, facing the channel, and inclinometer I4 was installed at the crest of the side slope (Fig. 5). The pattern of horizontal displacement was similar in both cases, with the largest displacements occurring at the surface of the soft soil. The results also show that the fast construction of the embankment caused much larger horizontal displacements (of the order of 20 cm) along the direction normal to the embankment axis (I4) than along the direction of the embankment axis (I3). This can be explained by the fact that the embankment axis direction coincided with the stiffest direction of the reinforcement, as commented before. Therefore, the reinforcement was capable of reducing the horizontal displacement along that direction, in contrast to what was observed in the transverse direction.

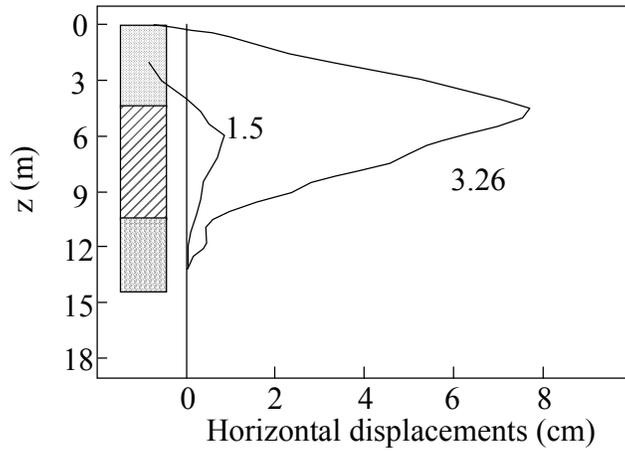
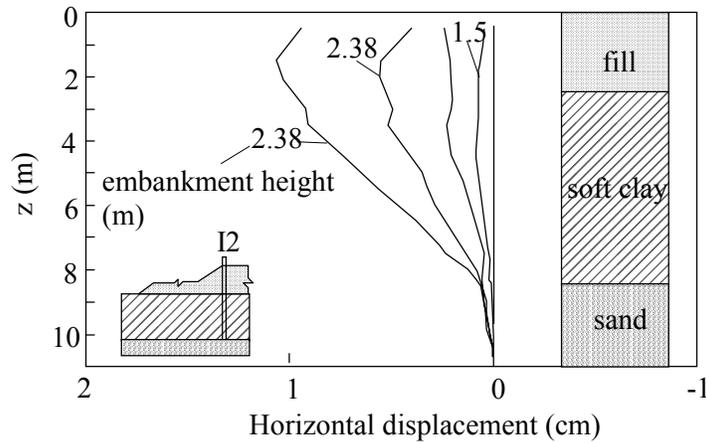
Figure 10. Horizontal Displacements in the South Abutment

The horizontal displacements measured by inclinometers I1 and I2 in the South abutment are presented in Figures 10(a) and (b), respectively. It should again

be pointed out that because the side slope of the North abutment almost failed, the South abutment was built with the side berm from the beginning of construction. For this reason the horizontal displacements in I2 are significantly smaller than in I1.

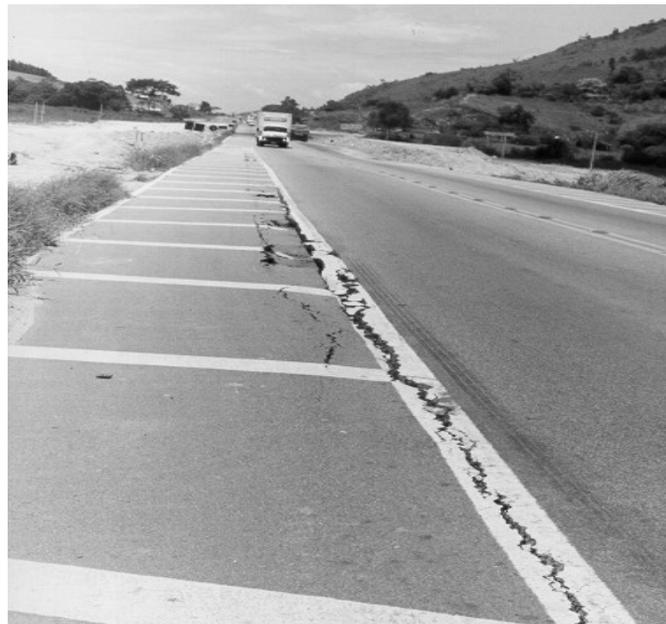
Figure 11. Cracks Along the Surface of the Pavement

Figure 11 shows cracks observed along the border of the old embankment that were caused by the settlement of the new embankment. Cracks with openings up to 6 cm wide were observed. As it could be seen in Figure 4, one of the new embankments extremities rested on the old embankment side slope. The consolidation settlements of the new embankment dragged the border of the old embankment down, causing tensile cracks along its surface.

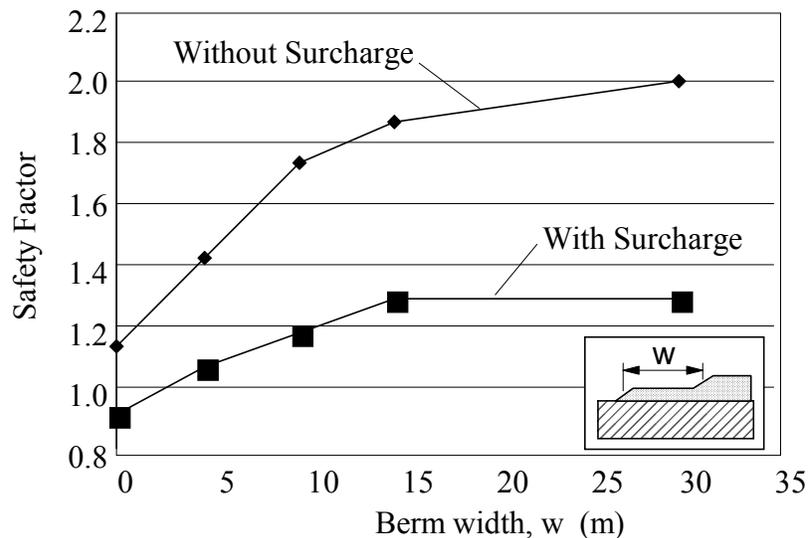
Figure 12. Effect of Berm Width on the North Abutment Lateral Slope Safety Factor.

When the presence of the 30m wide berm adjacent to the side slope is considered together with the removal of the surcharge, the predicted factor of safety

of the side slope increases to 1.98. This is a significant increase in the safety factor and suggests that the berm width may be quite conservative. Figure 12 shows the variation of safety factor, of the lateral slope of the North abutment, with the berm width as a function of the presence of the surcharge. Assuming no significant reduction of soil strength caused by the embankment lateral movements, the results suggest that, in the case of surcharge removal, a 5m wide berm might have been enough to ensure the embankment stability with a safety factor of the order of 1.4. If the surcharge layer had been maintained, a berm 15m wide would have raised the safety factor to 1.3.
