THE BEHAVIOUR OF THE INSTRUMENTATION OF AN EMBANKMENT ON CLAY

J. A. Ramalho-Ortigão¹, Willy A. Lacerda²
and Mauro L. G. Werneck²

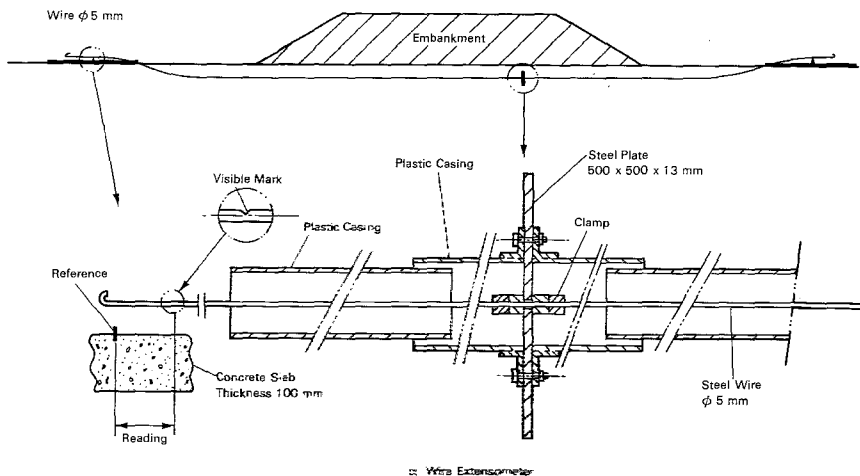
Fig. 3 Details of the wire extensometer

Measurements taken by the mechanical wire extensometer were too much affected by wire settlements under the embankments and, to a lesser extent, by wire dilation due to temperature fluctuations. A tentative correction of the first effect has not yielded good results, and measurements were considered only as an upper limit of horizontal displacements. However, due to the reliability presented by such a simple mechanical instrument, the overall pattern of movements presented by the measurements could be used for analysing displacement distribution along the embankment base. Its manufacture and installation were difficult and more expensive than the magnetic extensometer.

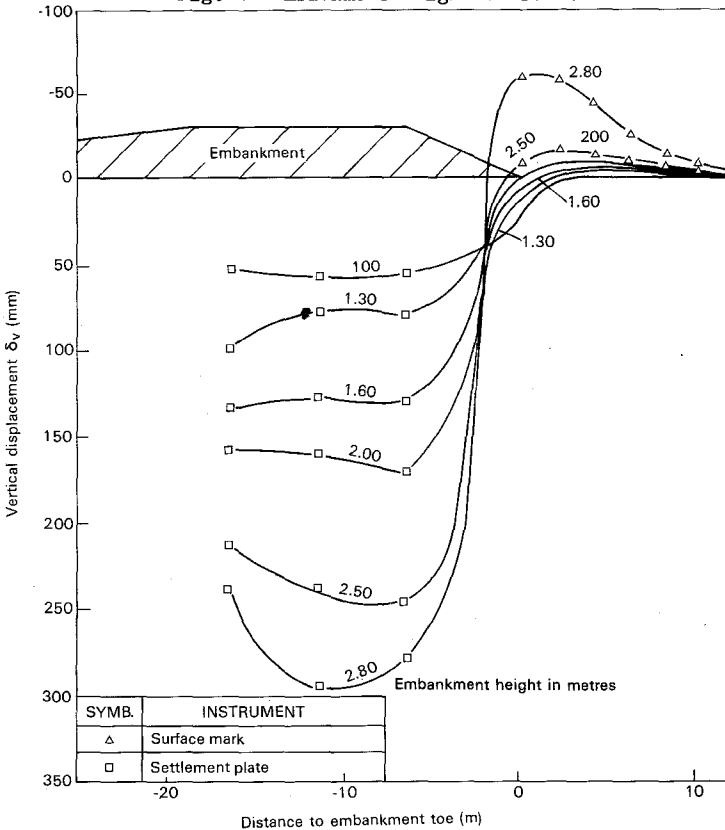
Fig. 5 Vertical displacement profiles under the base of the embankment

Vertical displacement profiles under the base of the embankment are shown on figure 5. At failure, the maximum observed settlements were in the

order of 300 mm, while ground heave near the toe of the embankment was about 50 mm. When the embankment height was increased from 2.5 to 2.8 m, a sudden change in heave observations was recorded. These readings show a 2 to 3 - fold sudden variation near failure. Another noticeable point on figure 8, is the high gradient of vertical displacements which occurs near the toe of the steeper slope of the embankment. At this position vertical movements at clay surface present a significant variation from positive (settlement) to negative (heave) in a few meters of horizontal distance.

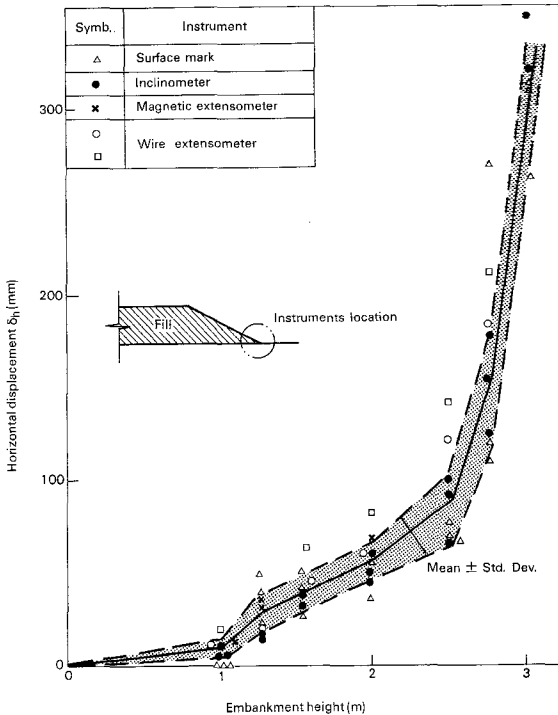
Fig 9. Observed horizontal displacements at the embankment toe

Horizontal displacements measurements are summarised in figures 9, 10 and 11. At the end of fill placement, maximum toe horizontal displacements are in the range of 300 to 400 mm. Maximum values seem to occur under the steeper embankment slope, rather than at the toe. The zone of influence of ground displacements seems not to extend beyond 10 m from the embankment toe.

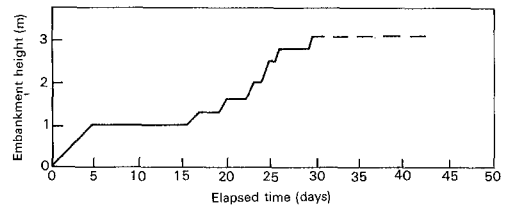
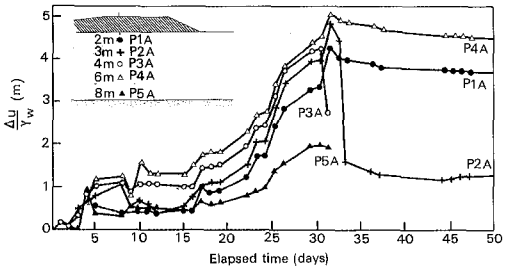
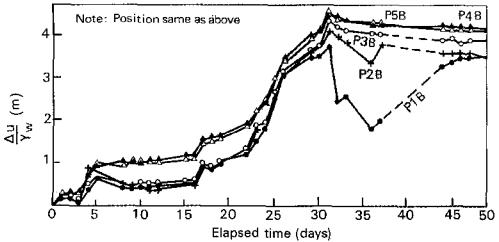
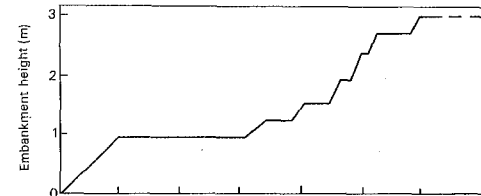
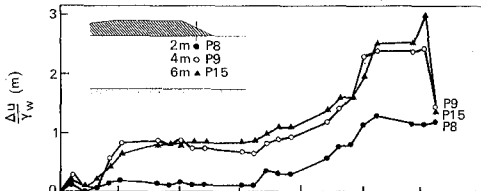
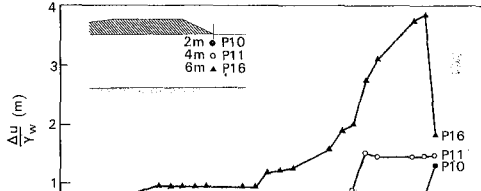
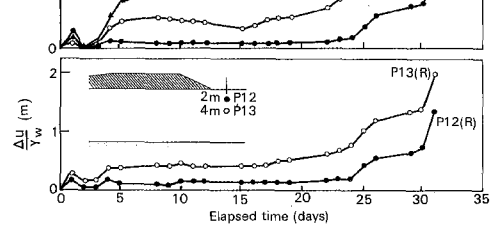
Fig.12 Piezometer observations

A summary of pore-pressure observations during embankment construction is plotted in figures 12 to 14. The piezometer response to load, as shown in figure 12, presents an initial flatter slope for the porous tip located closer to the surface, followed by a steeper slope. This typical behaviour had been previously interpreted by Lerouiel et alii (1978), who attribute the change in the rate of pore-pressure build-up to the phenomenon of clay foundation being altered from an overconsolidated state to a normally consolidated state. At failure, as local yield occurs close to the porous tip, pore-pressures seem to present a further increase in the rate of pore-pressure generation.
