# EMBANKMENT FAILURE ON CLAY NEAR RIO DE JANEIRO

By J. A. Ramalho-Ortigão,<sup>1</sup> M. ASCE, Mauro L. G. Werneck,<sup>2</sup>  
and Willy A. Lacerda<sup>2</sup>

**ABSTRACT:** The construction on an instrumented trial embankment on soft clay is described. Field measurements of pore-pressure and vertical and horizontal displacements were carried out and the results are discussed. Foundation strength was evaluated through vane tests, UU triaxial tests and SHANSEP method. Embankment failure occurred when its height was about 3 m. Stability analysis were carried out to evaluate methods of assessing soft foundation strength.

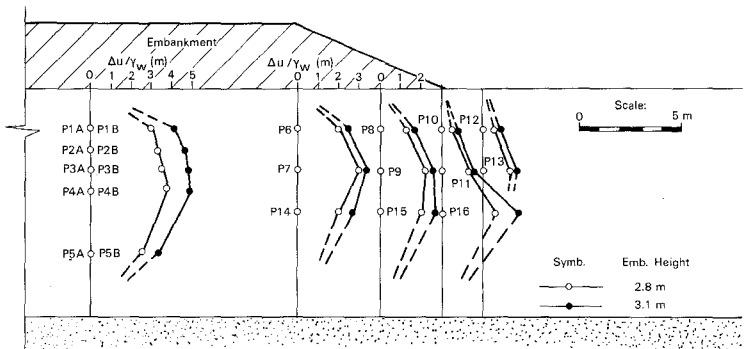
FIG. 13.—Observed Pore Pressures at Failure

A summary of pore-pressure increment observations during embankment construction is plotted in Figs. 12–13. The piezometer response to

load, as shown in Fig. 12, presents an initial flatter slope for the porous tips located closer to the top of the clay layer, followed by a steeper slope. This typical behavior has been analyzed by Lerouiel, et al. (13), who attributed the change in the rate of pore-pressure buildup to the fact of the clay foundation passing from overconsolidation into a normally consolidated state. At failure, as local yield occurs close to the porous tip, pore pressures seem to present a further increase in the rate of pore-pressure generation.

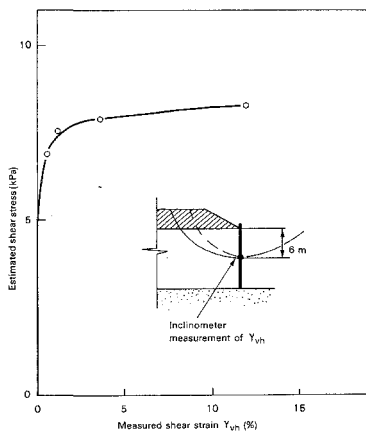
**FIG. 15.—Deduced Stress-Strain Curve from Measured Strains and Estimated Stresses**

An interesting way of exploiting strain observations is the possibility of deducing a "field" stress-strain curve. The observations of  $\gamma_{vh}$  at the embankment foundation were plotted against estimated shear stresses from a finite element analysis (22) yielding a stress-strain curve, as presented in Fig. 15. This information was used as input data for another FE analysis in order to simulate embankment deformation. The results of such an analysis, due to space limitations, will not be presented in this paper.

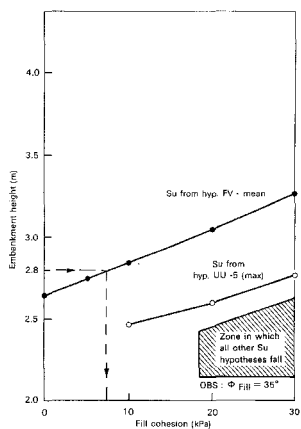
**FIG. 16.—Summary of Soil Parameter Assumptions which Yielded FS = 1 in Total Stress Stability Analysis**

Considering 16 assumptions on foundation strength, 6 assumptions on embankment strength, and 4 additional embankment heights (these latter in order to observe the variation of safety factor with embankment height), 256 cases were processed. The results were subsequently "screened" to produce the assumptions which yielded a factor of safety close to one. These data were then summarized in Fig. 16. Setting the height of the embankment which produced failure equal to 2.8 m (this seems to be a reasonable assumption since severe embankment cracking took place at this height), one can obtain from Fig. 16 a value for the mobilized embankment strength at failure. While the assumption of FV-mean for foundation strength yielded a reasonable value for embankment strength, all other hypotheses did not predict failure at 2.8 m, un-
