Embankment Failures on Soft Clay in Brazil

J.A. Ortigao

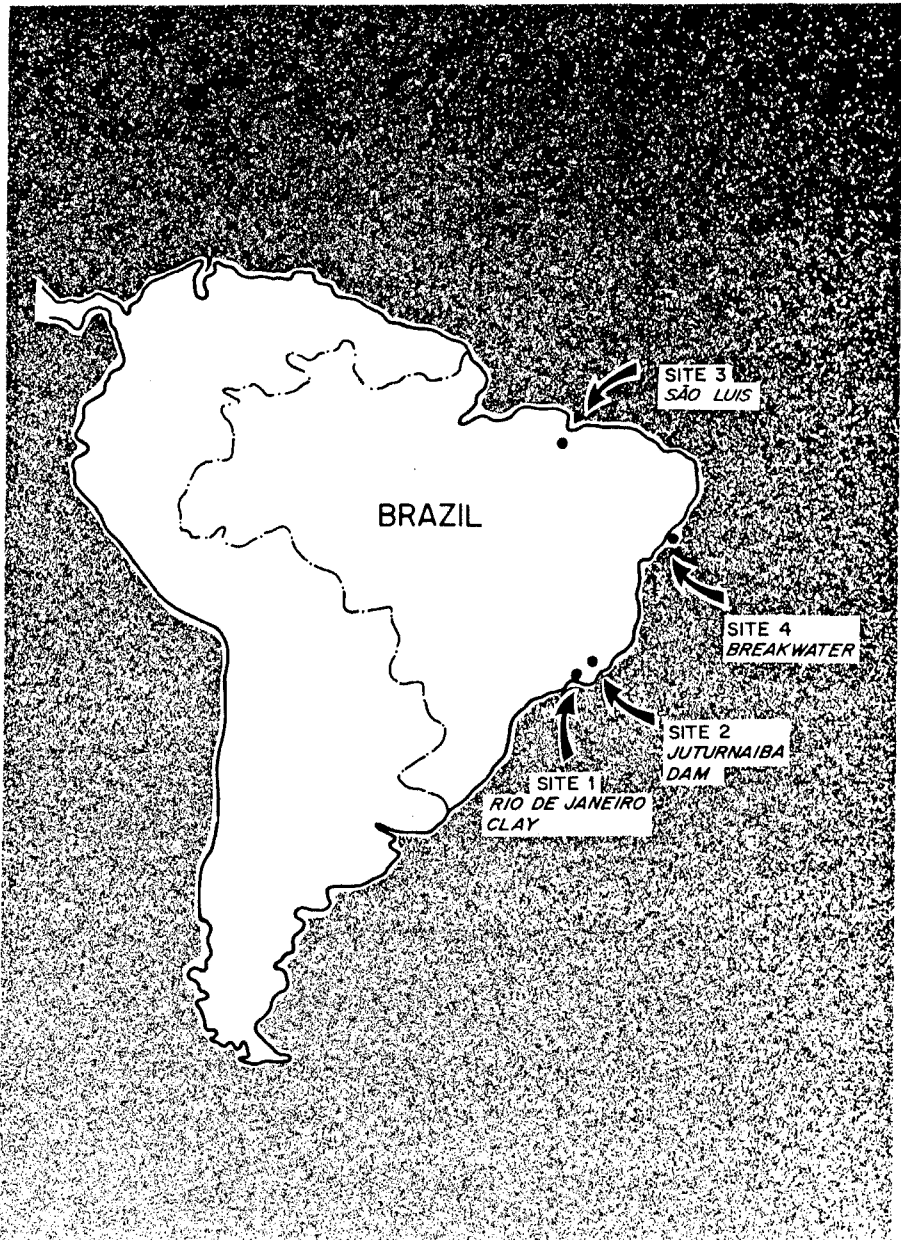
Figure 1 Location of failures

In the last 15 years a few well documented embankment failures have taken place at four different soft clay sites in Brazil (figure 1). The purpose of this note is to present a brief summary of this experience.
